# Manhole Inspection Summary

Manhole # S61K\_\_014MH

Insp Date: **7/8/08 1:49 PM**

**Location** Address: **901 s ponca st**

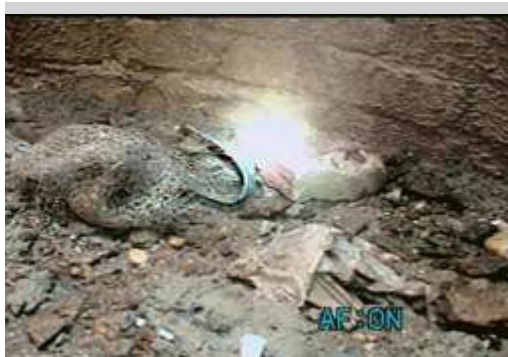
Misc. Defect 3

bench debris

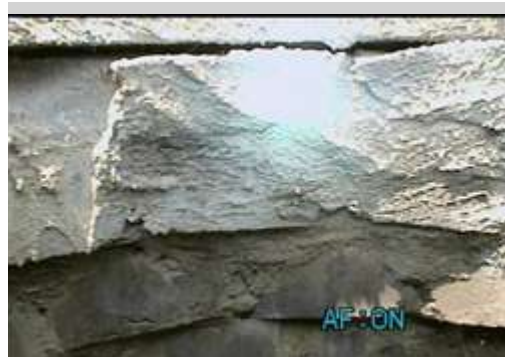
Misc. Defect 1

frame adjustment

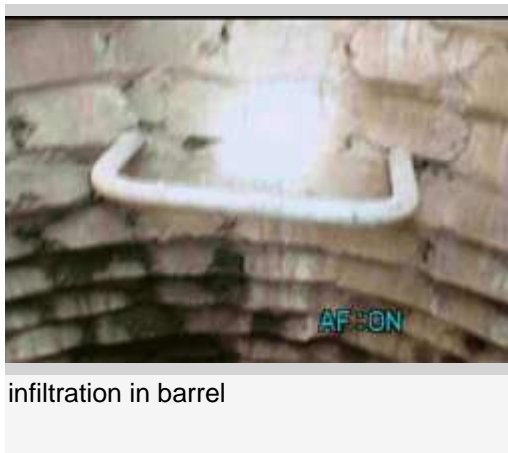
Defect 4

Infiltration: ☐ None ☐ Joint ☐ Cracks ☐ Mortar ☐ Roots ☒ **Wall**

infiltration in barrel

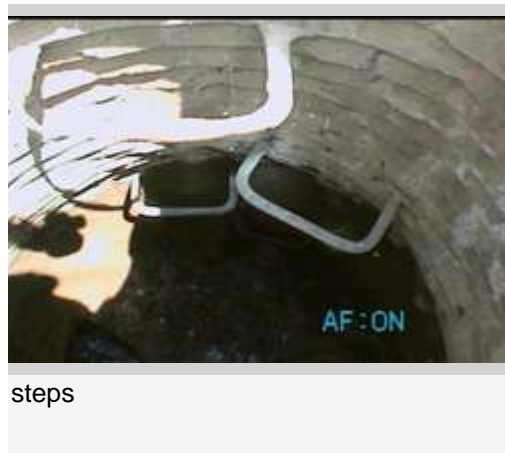
Defect 2

Count: **4** Missing: **0** ☒ **Corroded**

steps

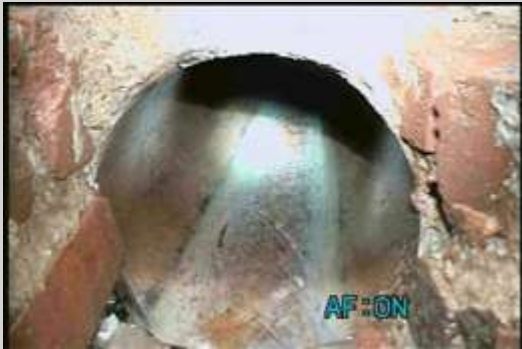
12 O'Clock Outflow

8 in. Circular Gravity Sewer  
Pipe Out @ 12 O'Clock

Invert Depth: **9.29** (ft.) Flow Characteristics: **Fast**

Infiltration: **None** Pipe Seal Cond: **Unknown**

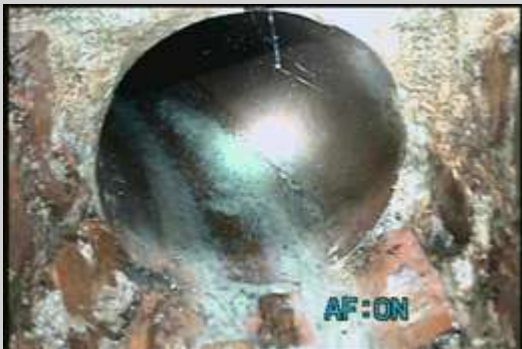
4 O'Clock Inflow

8 in. Circular Gravity Sewer  
Pipe In @ 4 O'Clock

Invert Depth: **9.24** (ft.) Flow Characteristics: **Fast**

Infiltration: **None** Pipe Seal Cond: **Unknown**

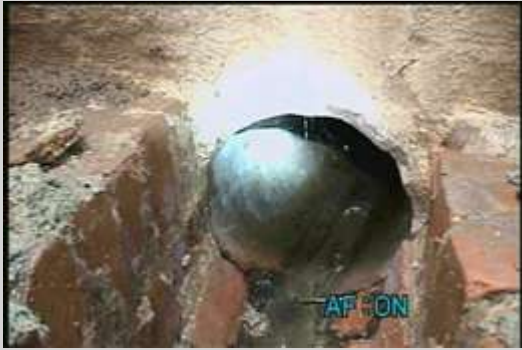
8 O'Clock Inflow

8 in. Circular Gravity Sewer  
Pipe In @ 8 O'Clock

Invert Depth: **9.18** (ft.) Flow Characteristics: **None**

Infiltration: **None**
